Interdisciplinary Science Building Project

Final
**Initial Study -
Mitigated
Negative
Declaration**

December 2017

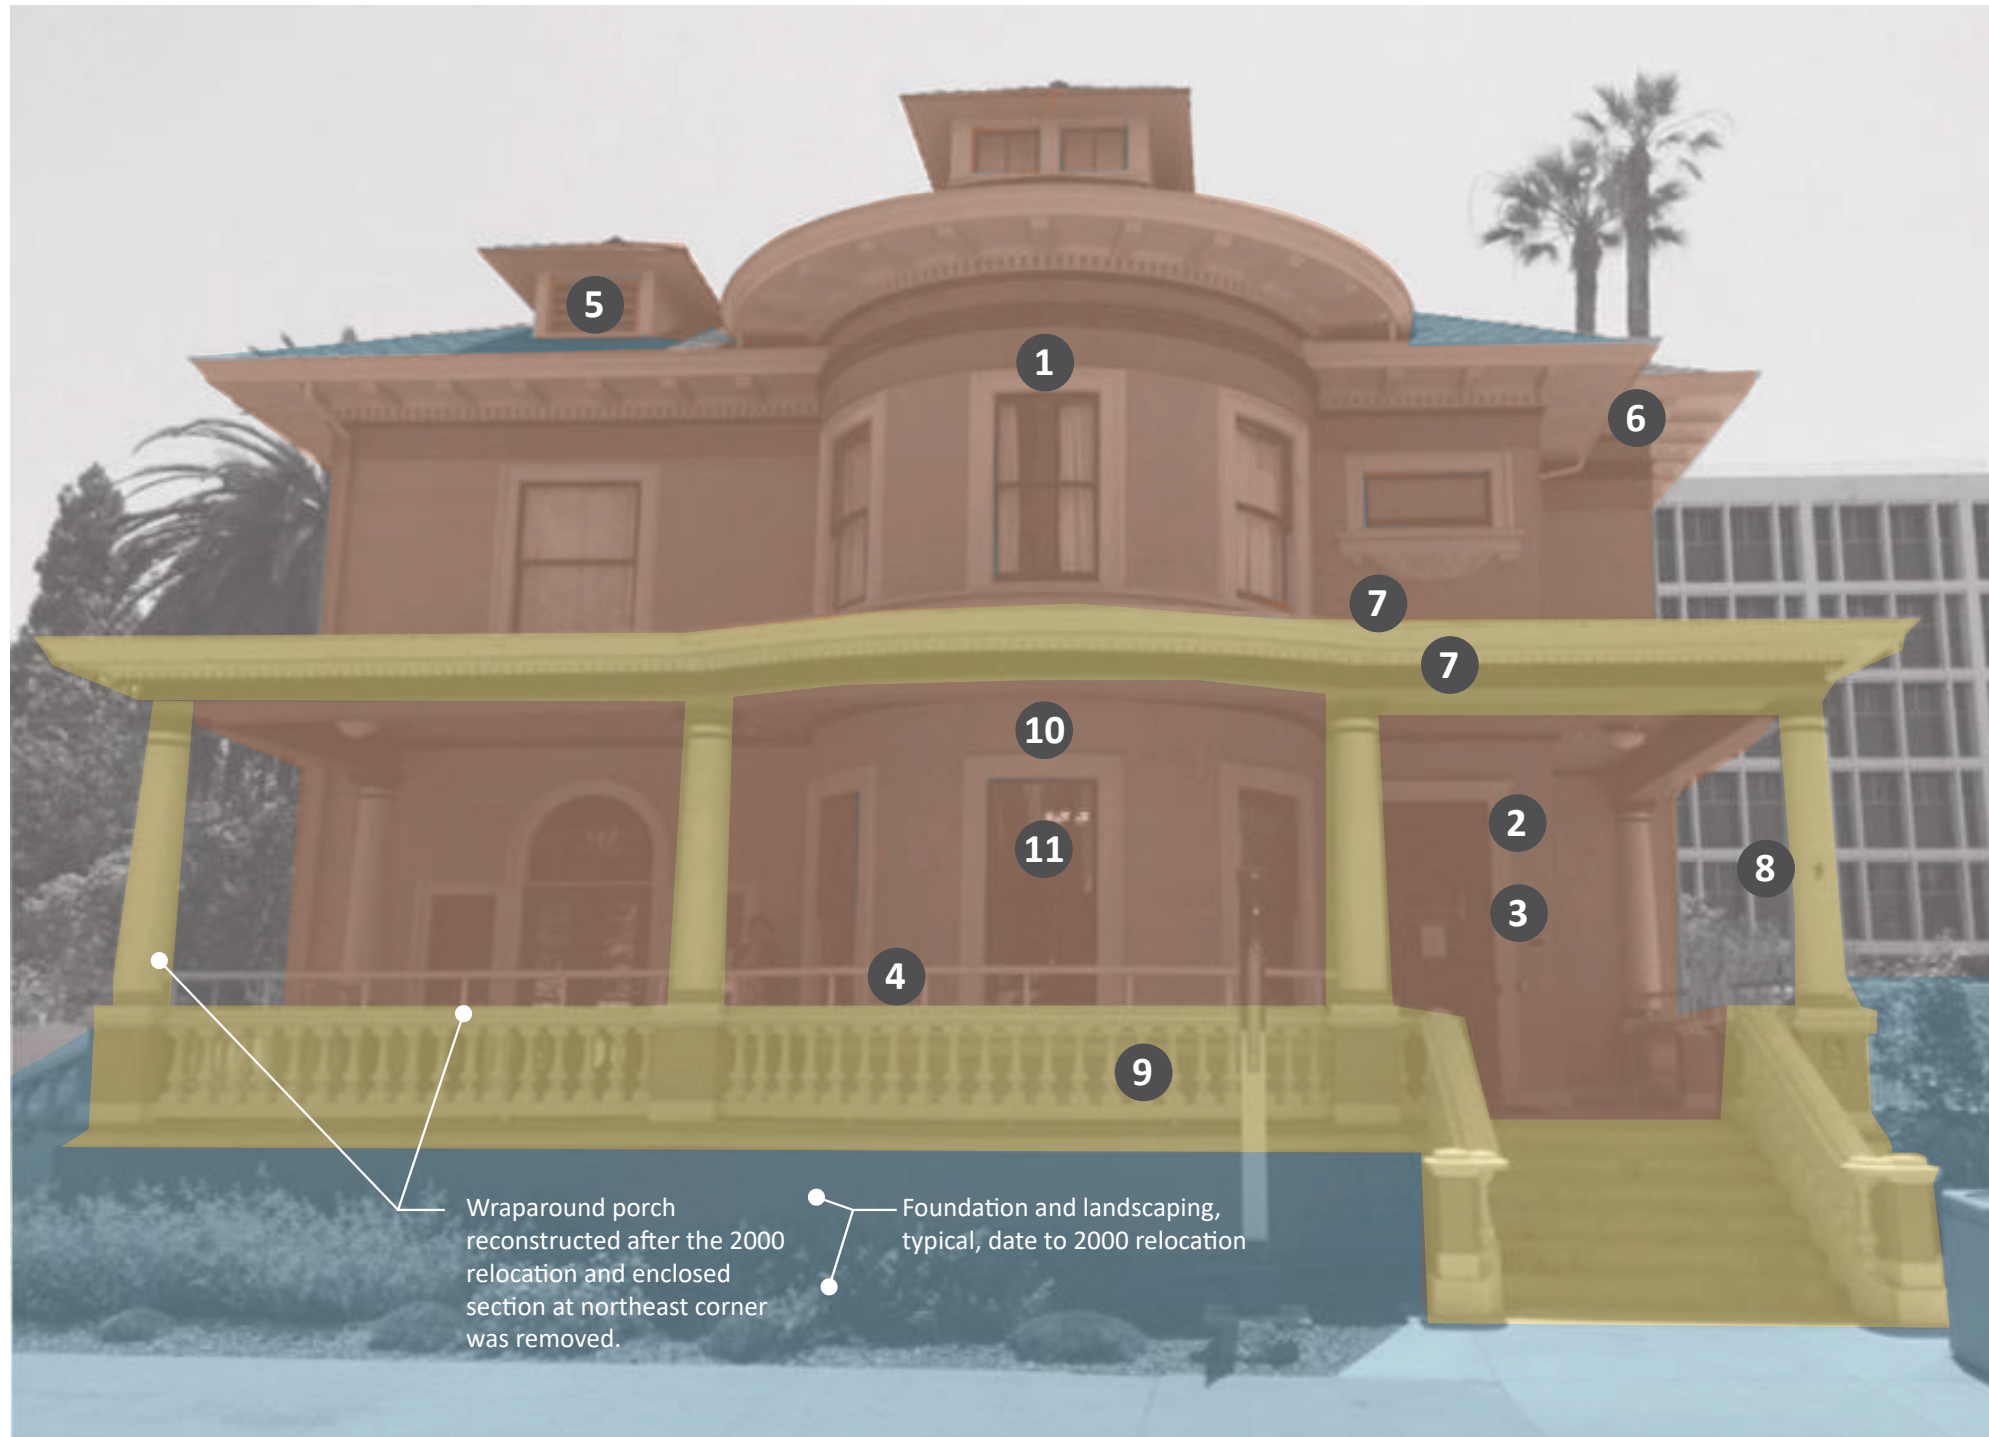
Primary (Northwest) Facade

1. Two-story residence with semi-circular tower
2. Asymmetrical massing and floor plan
3. Shiplap siding
4. Wrap-around porch
5. Hipped roof with dormers (Roofing material has been replaced)
6. Wide boxed eaves with exposed rafter tails
7. Modillions, dentils, classical frieze
8. Rounded columns
9. Spindle-post balustrade
10. Bay windows
11. Double-hung wood windows
12. Art glass windows

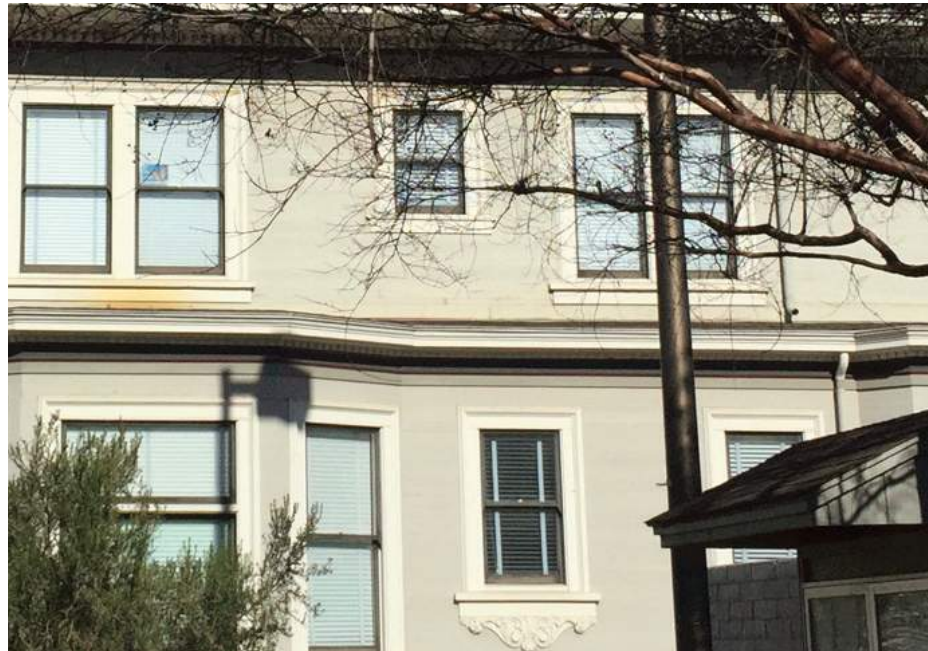
Yellow haze on exterior and deteriorated boards on second level, 2017 (Page & Turnbull)

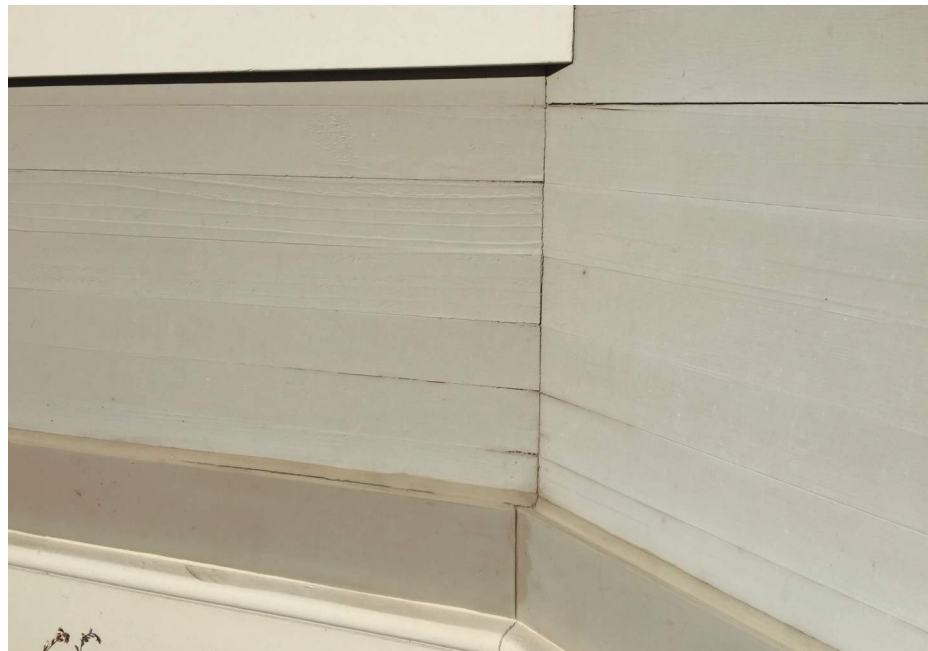
Typical deterioration of exterior boards at west facade due to sun exposure, 2017 (Page & Turnbull)

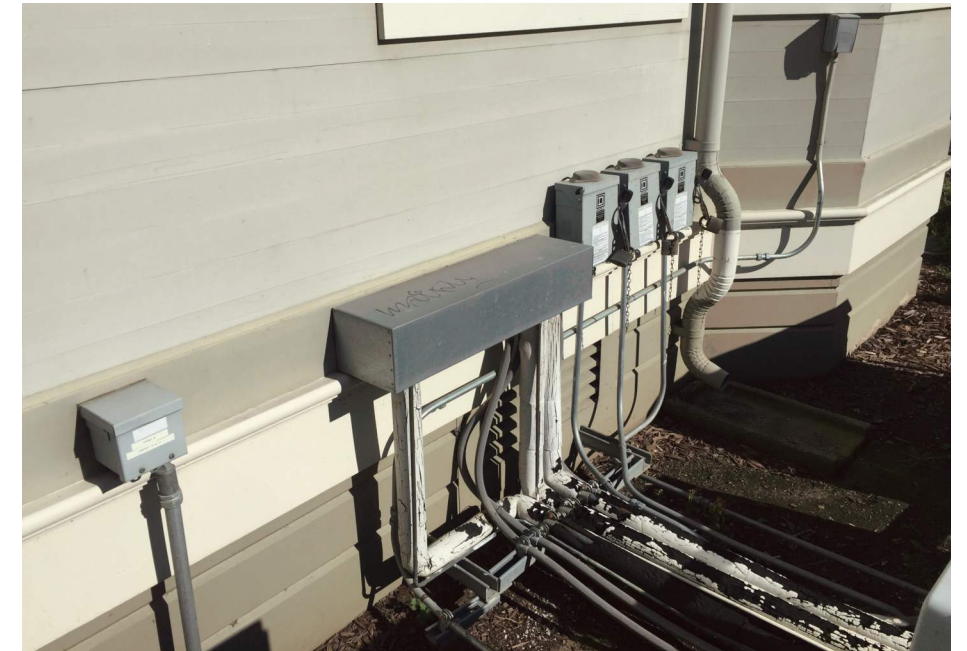
West facade utility ingress locations, 2017 (Page & Turnbull)

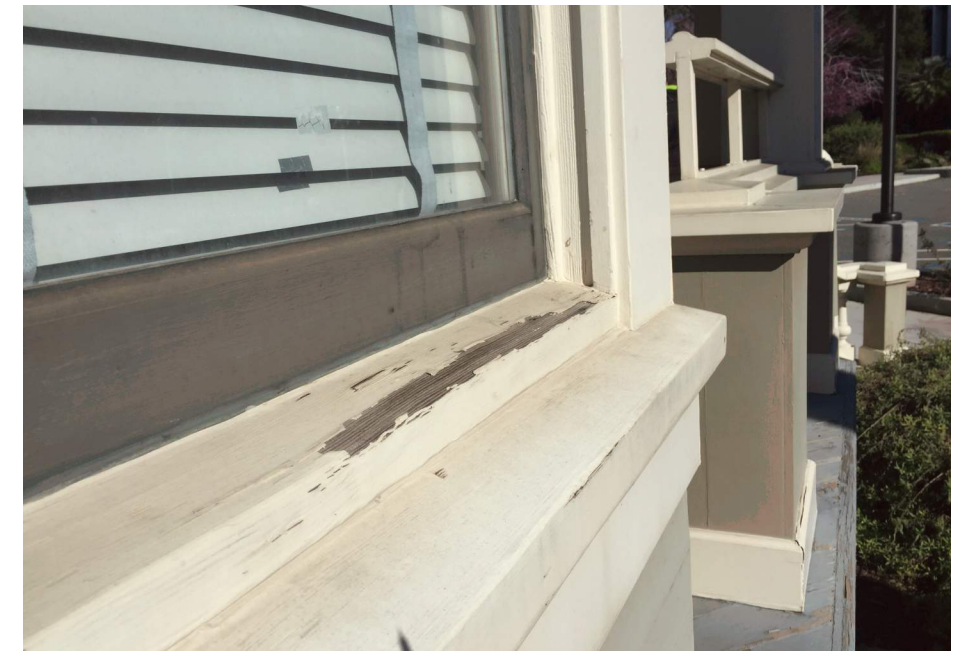
Sill and window joint deterioration, 2017 (Page & Turnbull)

- Windows everywhere but at the west facade were in good condition. At the west facade, multiple window sills and bottom sash rails had paint delamination and the beginnings of UV deterioration in the exposed wood. Some sashes were starting to show joint separation. Exposed wood surfaces (and areas with discoloring due to UV damage) should be repainted as soon as possible to protect the wood windows, ideally pre-move.

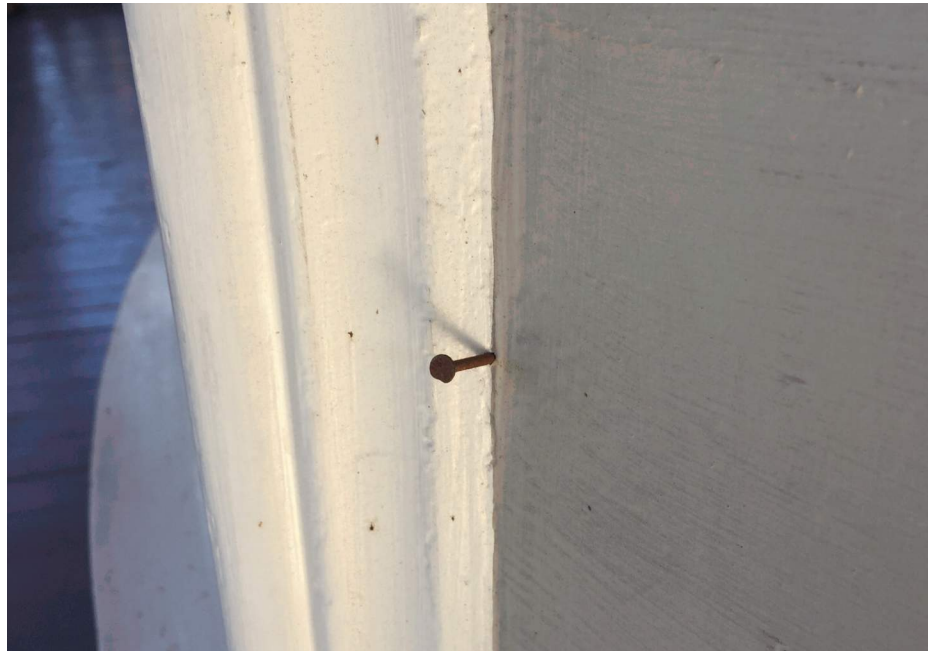
Nails used on the historic exterior should not be mild steel, 2017 (Page & Turnbull)

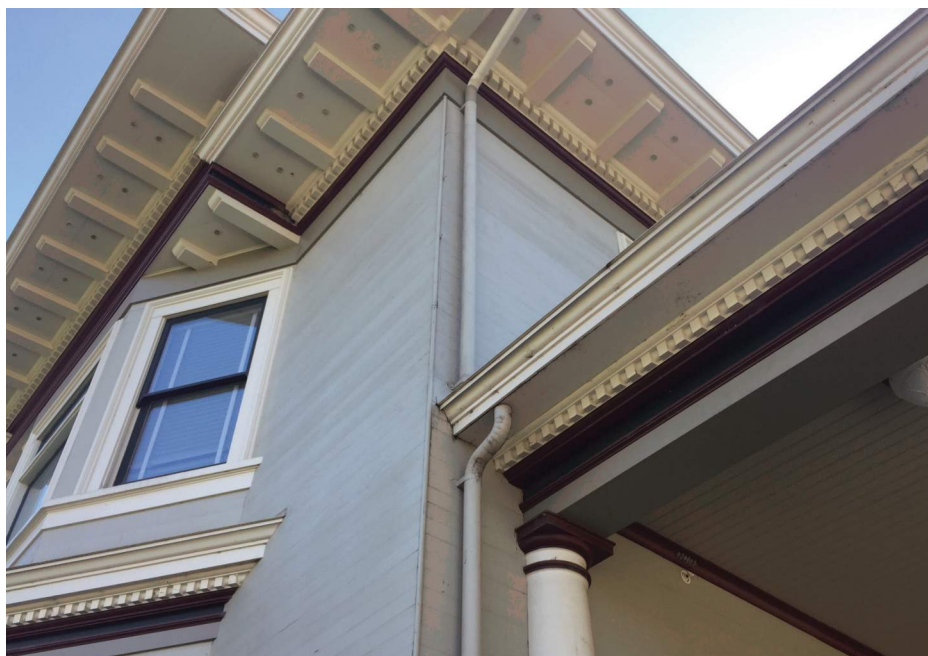
Possible deterioration of the exterior boards above the north porch , 2017 (Page & Turnbull)

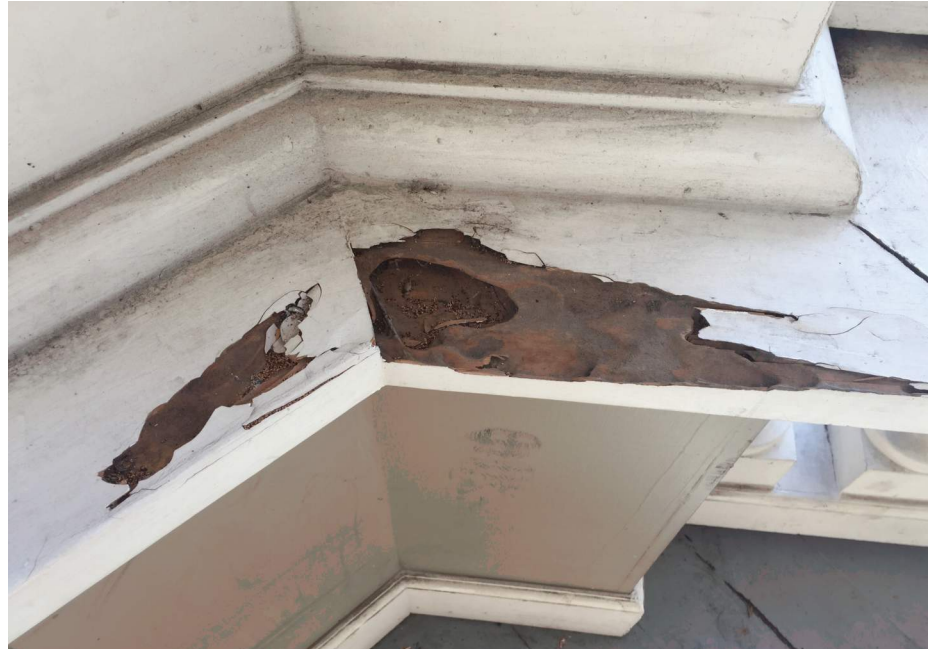
Insect damage in porch railing, 2017 (Page & Turnbull)

- The current non-historic porch railings are exhibiting two locations of major infestation damage, one at the north porch and one at the south. It appears that a burrowing insect has caused damage to the wood used in the porches since 2000. Other wood surfaces in the building do not show any signs of similar damage. Should the same plans be used for the porch recreation on the new site, an alternate wood variety should be selected to construct the porch details at the columns and balustrades.

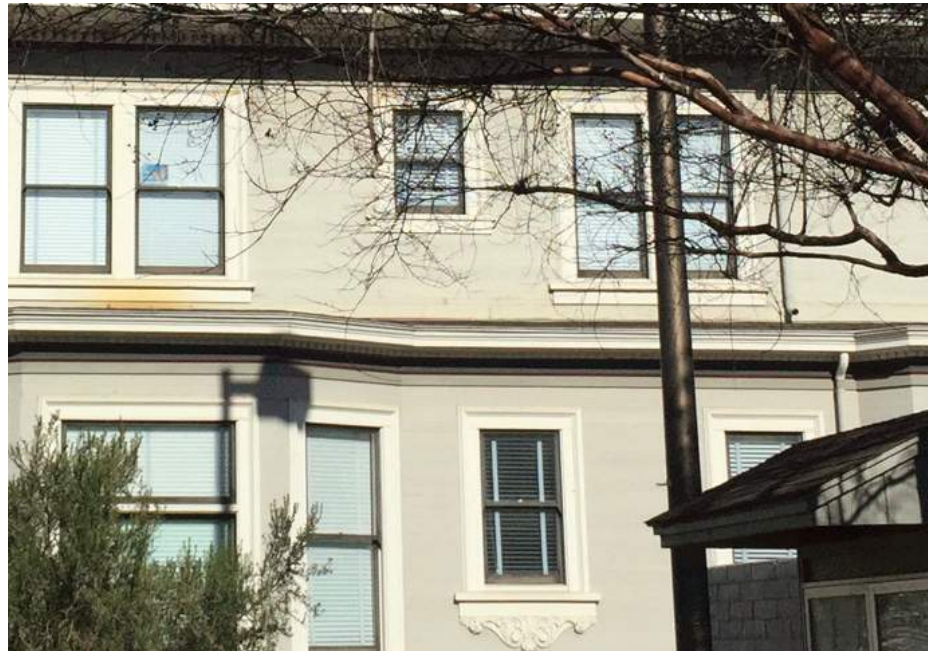
Yellow haze on exterior and deteriorated boards on second level, 2017 (Page & Turnbull)

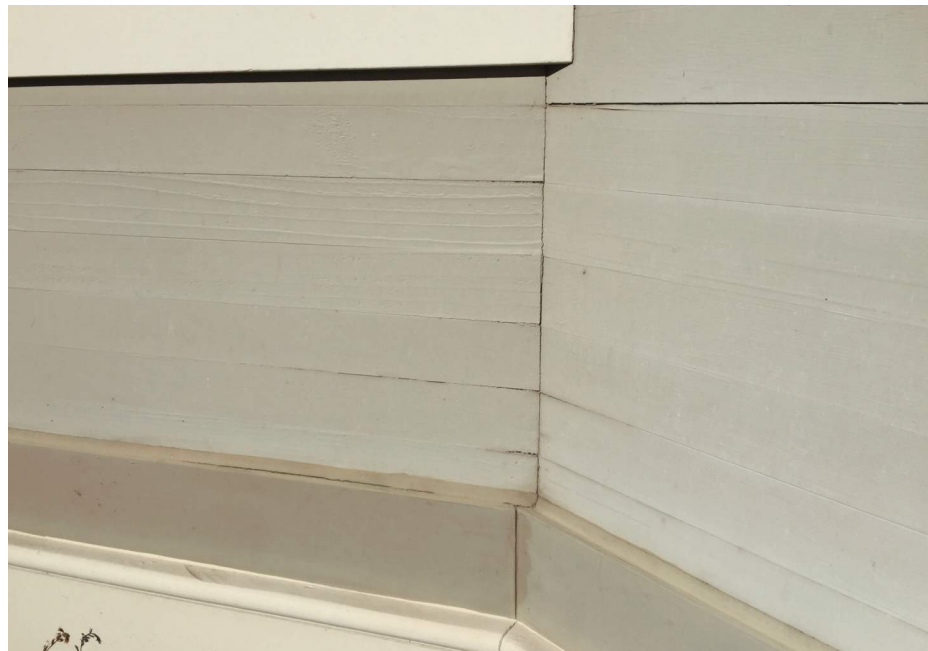
Typical deterioration of exterior boards at west facade due to sun exposure, 2017 (Page & Turnbull)

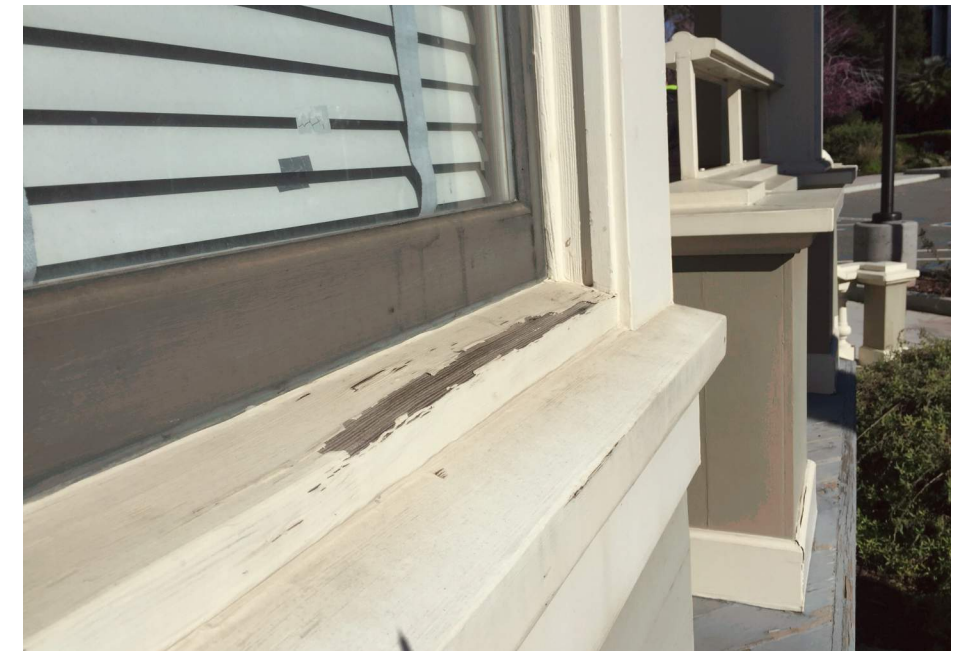
Sill and window joint deterioration, 2017 (Page & Turnbull)

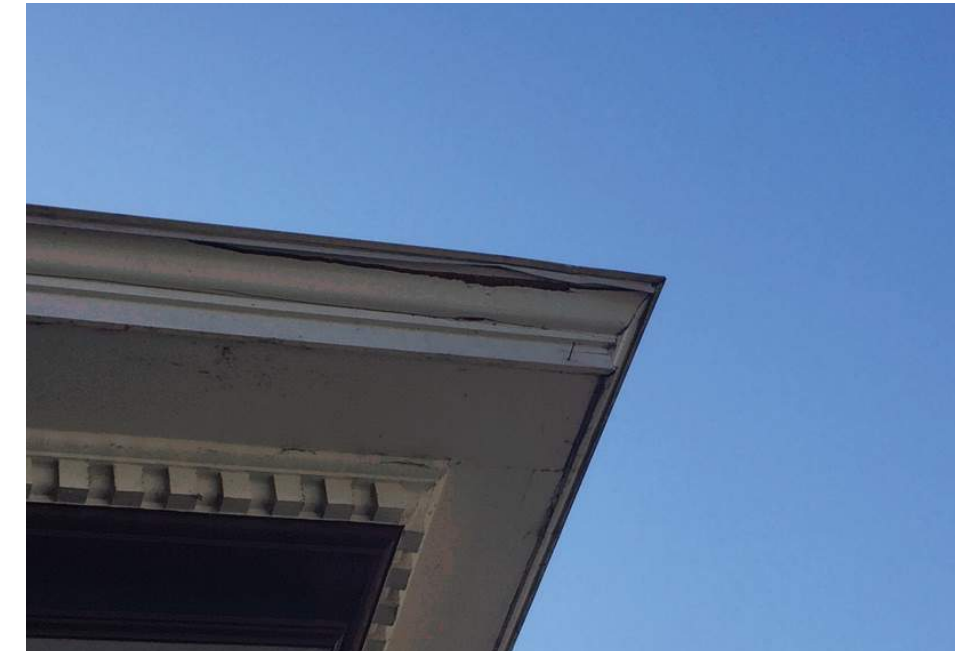
Broken roof edge, 2017 (Page & Turnbull)

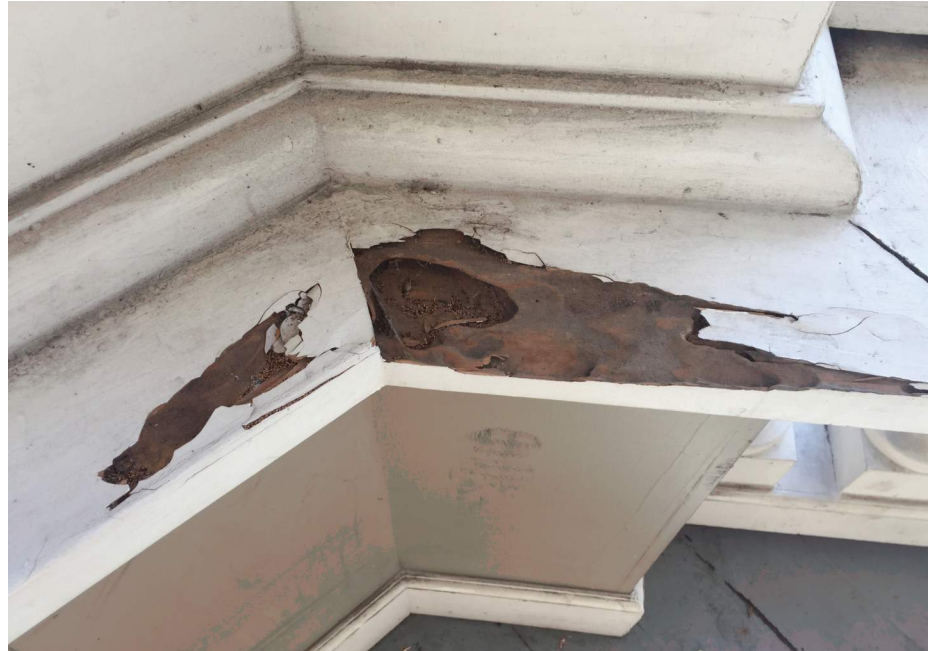
Insect damage in porch railing, 2017 (Page & Turnbull)
